STOPThink! Fractured Finger

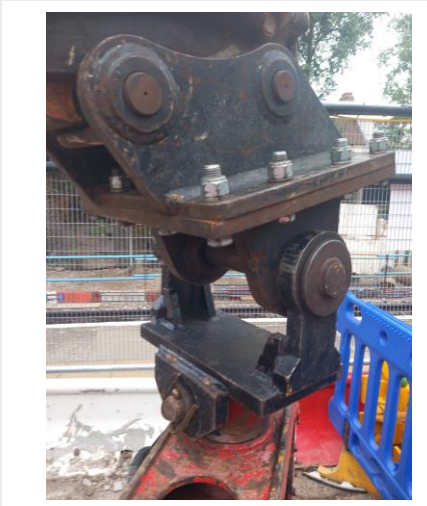
EMV attachment, upper plate visible

They asked for some assistance for it to be moved. In the interim whilst waiting for assistance they tried to manoeuvre the attachment. This led to the top plate of the EMV rotating on the lower swivel point and trapping the little finger of his left hand.

- If it is suspected that a heavy item is insecure or unstable, assess the situation and create and maintain an exclusion zone. This removes people from the hazardous area and risk of injury and allows time for further assessment and resolution.
- Only those that are trained and competent should have interaction with moving plant and their attachments.

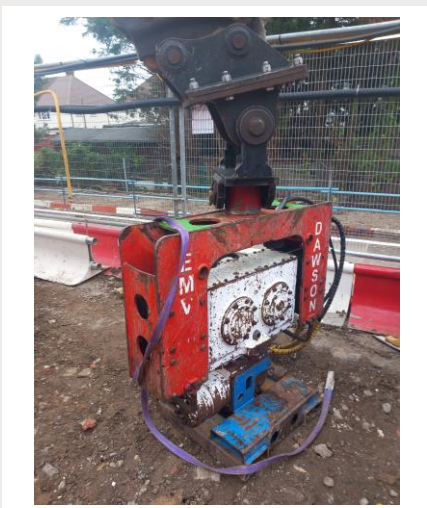
EMV attached to excavator quick hitch.

Despite concerns, the EMV was stable in its cradle and was not at risk of falling.
