# STOPThink!

## High-Potential Excavation Incident

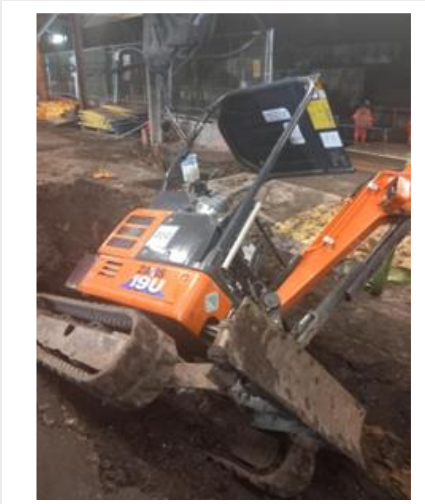
Final position of mini digger

After a change in the agreed method of working, a 1 tonne mini digger slid into the excavation following the trench side wall failing.

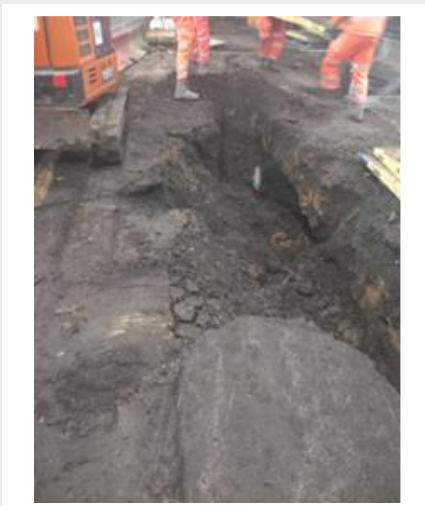
Sidewall failure and make up of ground
