## Safety Bulletin

## Konux Sensor Incident

Ref: NRB24-09

Location: Preston Park, Brighton, Sussex., Southern

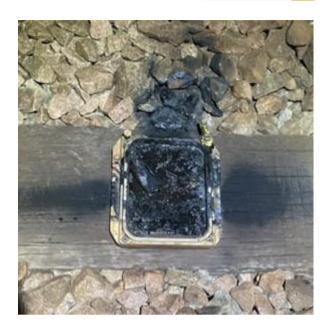
On 6 August 2024, during a site walkout near Preston Park in Sussex, a KONUX Connect sensor was found in a catastrophically failed state during a site visit with debris over 20m away.

These devices are used to monitor sleeper and bearer movements, this device was experiencing higher than normal vibration levels. This device was installed in February. In April the device self-reported a condition issue and stopped working in May. The catastrophic failure occurred at some time between 29 July 2024, when an intact device was captured on train-borne video, and the day of discovery.

The cause of failure is yet to be determined.

Most sensors, ~95 %, are fully functional, continue to monitor asset conditions and are not experiencing extreme conditions leading to a very low likelihood of catastrophic failure. Whilst Konux continues to monitor devices' health and status, users should contact Konux when they note devices are not reporting and they are unaware of planned interventions.
