STOPThink! Milford HV Cable Damage

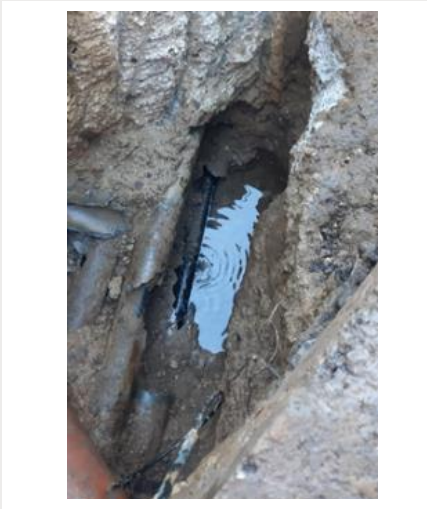
The sheath of HV feeder F2205 was damaged with 110v breaker whilst clearing concrete from ducts and excavating for a new Under Road Crossing (URX) feeder route. The cable was leaking oil and a spill kit was placed. There was a switch out of the Feeder in place at the time of the incident (i.e. cable wasn't live), and a Vacuum Excavator had been used for the majority of the works.

- There was no injuries, but the Feeder will remain isolated pending repair for up to a week.

1. COSS/HV Comp and operatives were stood down, for cause D&A testing completed (results pending)
2. Leaking oil contained, emergency spill protocol followed and Adler and Allen attended site to collect contaminated spill kits and apply remediation detergent
3. Reported through relevant railway reporting channels
4. NR Mobile Operations Manager and maintenance teams attended site
5. Maintenance supported by APS (Octavius jointing supplier) confirmed cable could not be repaired in situ.
6. Isolation & Earth (I&E) implemented to take feeder completely out of service
7. Planning for reinstatement has commenced, two viable options being progressed

- Ensure that appropriate control measures are in place when working around high voltage cables.
- Test and document emergency spill response arrangements
- If ground conditions are experienced which are not as planned, stop and seek assistance
