# STOPThink! Finger Injury Ryde Pier

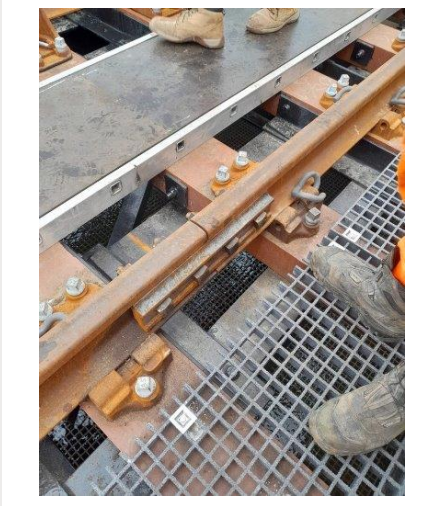
Example of a Fish plate Rail Joint

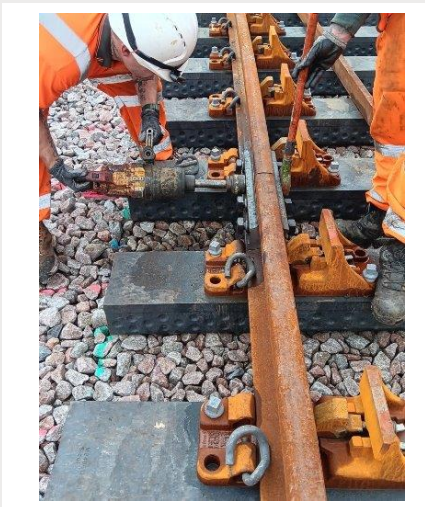
Method for installing/ removing fish plates
