Event details

Date of incident: 23.09.24

Location of incident: Isle of Wight

Discipline: Track

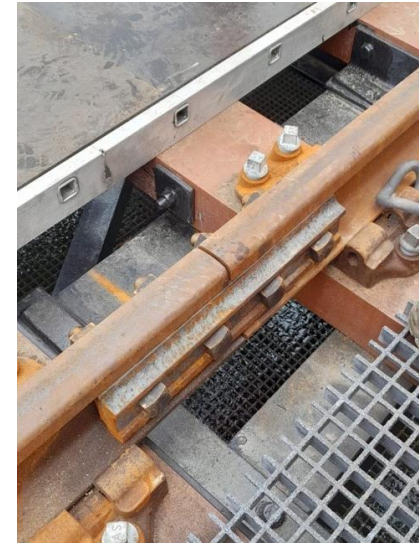
Event description: A P-way operative was standing adjacent to a fish plate which was about to be removed. They thought they had dropped something and bent down to check. As they did this, they placed their hand on the rail head. At the same time an impact wrench was used by another operative to remove a nut. As the bolt head moved, the first operative sustained an impact injury to their index finger as it came into contact with the rotating nut/bolt assembly.

Example of a fish plate

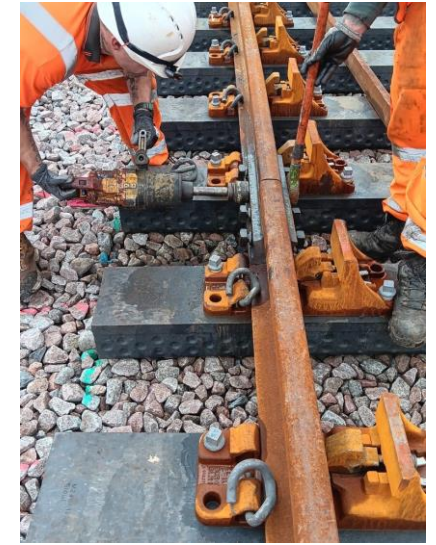
- The operative about to use the impact wrench didn't hear the injured operative ask him to hold works as they put their hand on the rail.

Method for installing/removing fish plates

- Operative was given immediate first aid, then taken to hospital on the Isle of Wight.
- Works of this nature were stood down and all personnel rebriefed on the correct method of fishplate bolt removal as investigation proceeds
