## Event details

**Location of incident:** Millbrook

**Discipline:** Track

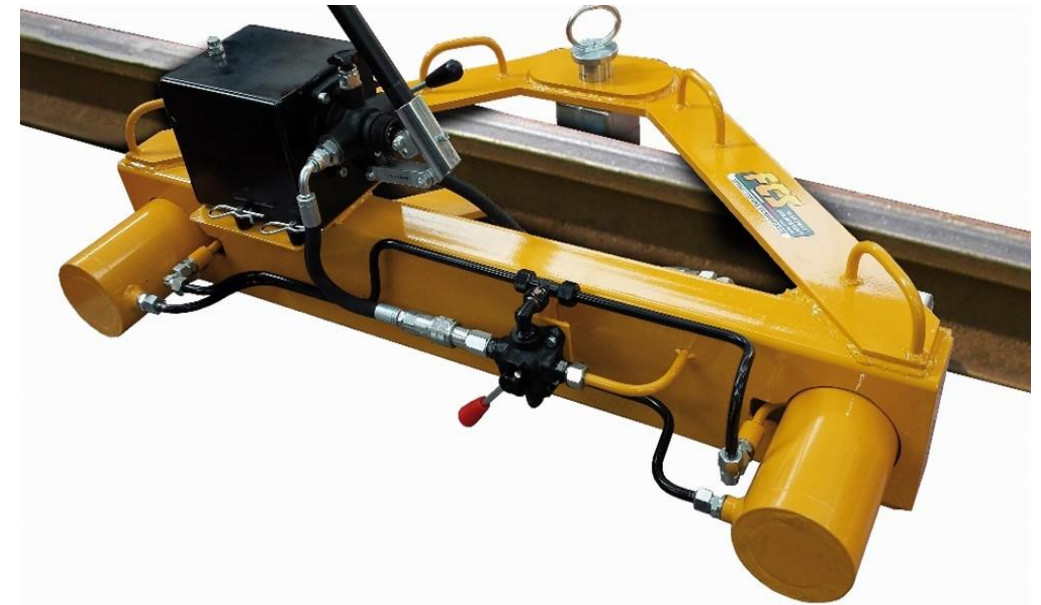
It was reported that whilst in the process of manually lifting the 'Ramper' onto the rail trailer, a member assisting with the lift stepped onto the trailer causing the 'Ramper' to twist, directing the weight of the load through the IP's bicep.

The IP states that 3 persons (including the IP) were undertaking the lift at the time and that the 'Ramper' is estimated to weigh approximately 120kg.

Photo: Hydraulic Rail Bender (Ramper) – *Illustrative purposes*
