## Event details

**Date of incident:** 28/09/2024

**Location of incident:** Milford Level Crossing Godalming

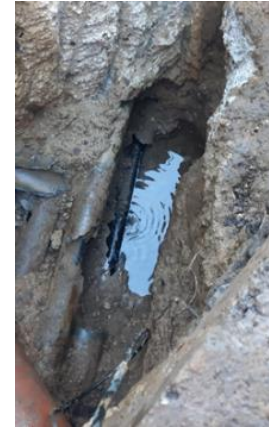
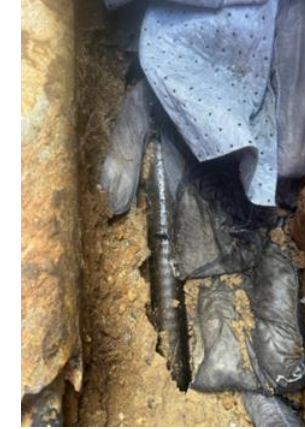
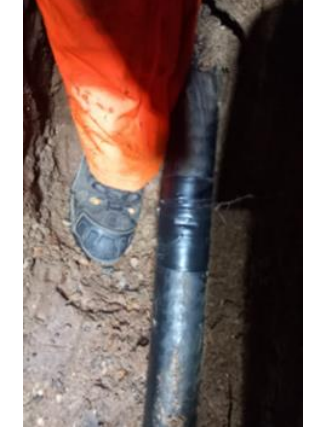
What happened – Sheath of HV feeder F2205 damaged with 110v breaker whilst clearing concrete from ducts and excavating new Under Road Crossing (URX) feeder route. Cable was leaking oil, spill kit was placed. Note there was a switch out of the Feeder in place at the time of the incident (i.e. cable wasn't live), and a Vacuum Excavator had been used for the majority of the works.

The individual using the breaker has inadvertently damaged the Feeder cable whilst breaking the concrete surrounding it.

- COSS/HV Comp and operatives were stood down, for cause D&A testing completed (results pending)
- Leaking oil contained, emergency spill protocol followed and Adler and Allen attended site to collect contaminated spill kits and apply remediation detergent
- Reported to WICC & ECR - MOM and maintenance attended site
- Maintenance supported by APS (Octavius jointing supplier) confirmed cable could not be repaired in situ.
- Isolation & Earth (I&E) implemented to take feeder completely out of service
- Planning for reinstatement has commenced, two viable options being progressed
