What Happened?

On Friday 22nd November at the Long Stratton Bypass project, a 20-tonne articulated roller, came off the top of a soil bund whilst completing the finished level. The machine was tracking backwards along the edge of the bund when the roller element started to slide down the bank. To stop the slide, the operator attempted to counter-steer the wheels which resulted in the roller sliding down the embankment, and once at the bottom, tipped onto its side. There were no injuries sustained, and only minor damage was noted on the machine. The investigation has commenced, and more details will be shared as the investigation unfolds.

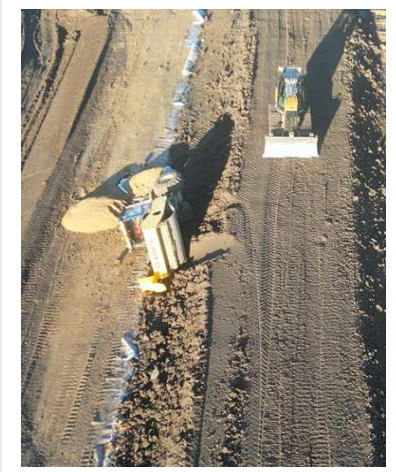
Overhead Image of the roller

- The risk assessment clearly specifies that the roller must not be taken within 0.5m of any leading edge.
- There was no edge protection bund in place as the works were at finishing layer and no other control was in place to prevent proximity to the edge.

- Investigation commenced.
- A review of the risk assessment was undertaken which highlighted that this risk at this stage wasn't considered.
- Projects with Earthworks identified and given advanced warning.
- Our Supply chain partner is exploring improvements to current working methods i.e. introducing marker poles along edge of embankments to highlight their visibility to mitigate this risk in future.

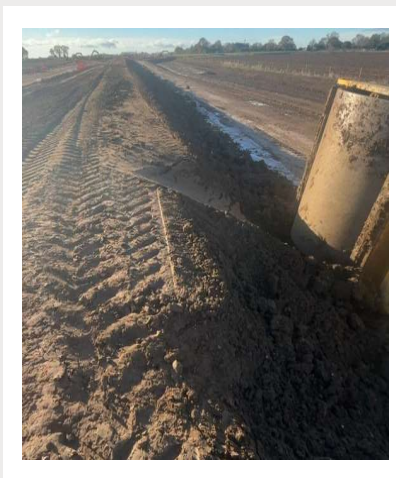
Top of bund
