What Happened?

On Wednesday 5th February at Long Stratton, a BT cable supplying an isolated property bordering site, was severed whilst works were being undertaken to remove existing tarmac and locate the pathway and depth of the known service. Trial pits had failed to locate the service in two areas, so an excavator was used to scrape off some of the top soil as the ground was hard, at which point the BT cable ducting was struck and broke the cable.

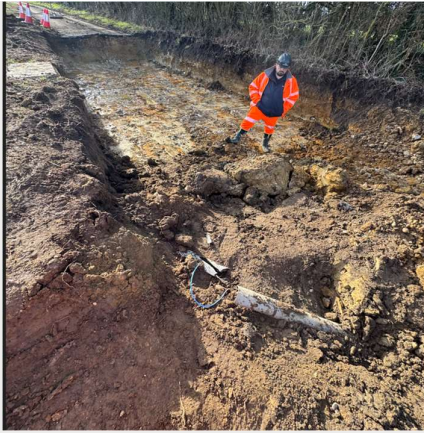
Location of service strike with chamber adjacent.

- The service had been traced with a CAT & Genny prior to works, markings were made with red line-paint, and the permit had been briefed to the team.
- SSoW / RAMS does not state about digging within 500mm is prohibited. This is only a note on MG permit.
- The POWRA does not identify that a service is known to be in the area.
- Area was not left sterile after the event and the plant involved was moved to another location.

- A review of the risk assessment for earthworks to be undertaken by supply chain.
- Work gangs were stood down and investigation commenced.
- Permits/permitting are being reviewed on site.

- Ensure safe digging practices are always followed.
- Ensure that the Point of Work Risk Assessments adequately address all known risks present.
- Ensure that all persons involved in the task detailed in the SSoW understand and comply with control measures
- Supervisors must ensure that operatives comply with works in their control.
- Ensure that all the “Stop Think Fundamentals” are in place prior to undertaking any works.
- If in any doubt whatsoever about what action to take “Stop Think” and consult your Line Manager or Safety Advisor.

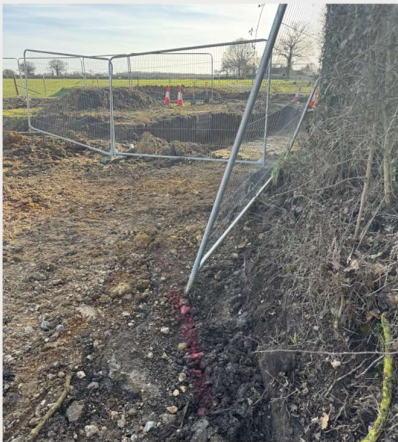
Marked up area for service.
