STOPThink!

Hedge Cutter Leg Injury

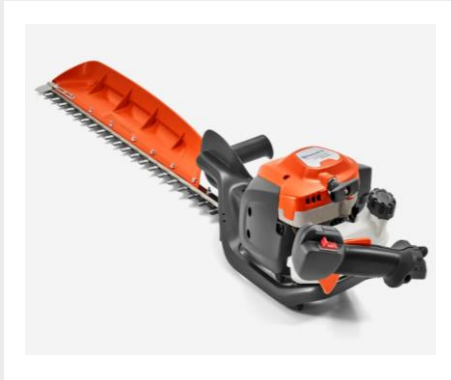
Hand-held Hedge Cutter, Model Husqvarna 522HS75X used on site.

A member of supply chain working for Octavius injured their left leg when clearing low level vegetation with a hand-held hedge cutter. The equipment got caught in a bramble and as the operative pulled it backwards, the cutter came into contact with the IP's left leg causing a laceration to their shin. First Aid was immediately provided, and the IP attended A&E for further assessment. The injuries were assessed, and the laceration was glued at the A&E.

1. **Remember**, only competent operatives must use hand-held tools like hedge cutters and understand actions to be taken if the tool becomes entangled.
2. For brush and hedge cutting operations, protective jackets and trousers must contain cut resistant material at the front of the garment. Specialist gloves, head and face protection must also be worn. Where required, this PPE must also be hi-visibility, EN ISO 20471.
3. A PPE check must be completed by the Supervisors to ensure all mandated PPE is being worn by operatives undertaking de-vegetation activities.
4. **Reminder**, the exclusion zone for strimming and brush cutting type operations is 15 metres. The Supervisor shall be responsible for ensuring the exclusion zone is always enforced.
5. First aid risk assessments must consider the task specific risks and the relevant first aid equipment must be available.
