STOPThink!

Working near overhead lines

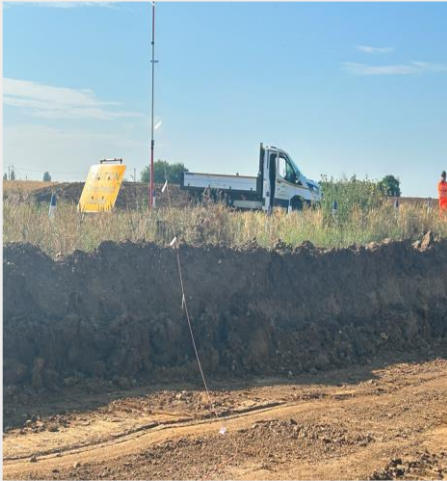
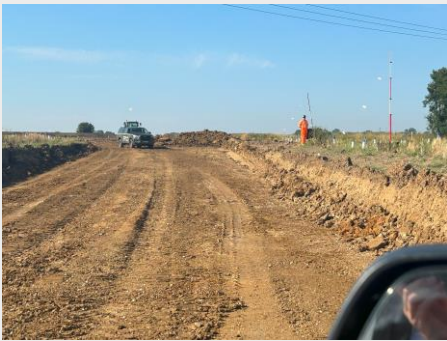
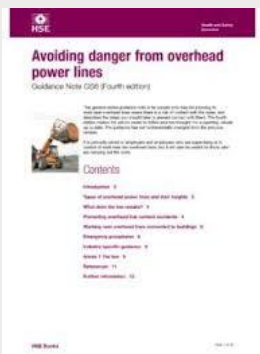
A 360 excavator was tracking to the works area carrying ditching buckets in the main excavation bucket. Whilst travelling under GS6 overhead line protection of overhead 11kv power lines, caught two goalpost lines bringing them down.

- There were no injuries although the potential for serious harm was high - the GS6 protection is a control measure in place to prevent the possibility of contact with or arcing from overhead lines.
- All site traffic was halted as the control was no longer effective having sustained damage.

1. Traffic through area halted / works stopped.
2. Both the excavator operator and the banksman were drug and alcohol tested.
3. Full Investigation commenced.
4. Safe repair of damage and reinstatement of GS6 protection planned and undertaken.
5. Haul road level reduced to increase clearance available before works recommenced.

- Ensure that SSoW includes reference to GS6 guidance document and explains the controls in place locally including safe configuration of plant and use of all available alarm systems.
- Ensure that all GS6 controls are in place, communication of these is understood before works and SSoW complied with.
- Report any damage or issues as soon as they are observed.
- **Please confirm via the [SHEA mailbox](#) that the above review has been completed where appropriate, by no later than 31 July 2024.**
