# STOPThink! Vacuum Excavator injury

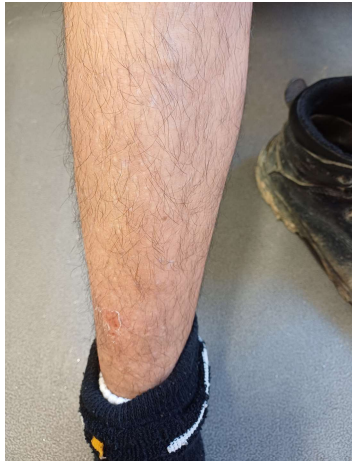
Minor bruising to shin.

On Thursday 14<sup>th</sup> November at our works on the PRA at HS2 Aylesbury a supply chain operative has sustained an injury to his right leg after it was sucked into the hose extension of the Vacuum Excavator. The operative is alleged to have been using his foot to sweep arisings from the excavation back towards the hose which subsequently sucked his leg up to his shin into the extension hose. The Vac Ex operator shut off the machine immediately and the IP was attended to. The IP was taken to hospital to be checked over and currently it is believed to be only minor bruising. The investigation has commenced and more details will be shared as the investigation unfolds.

- Works stopped, investigation commenced. Vac Ex works halted until review.
- A review of the risk assessment for safe use of, and people plant segregation for Vac Ex equipment is being undertaken.
- A safety briefing will be delivered re-enforcing the requirements for people plant segregation and safe proximity to specialised equipment.

- Ensure that all SSoW/RAMS etc are suitable sufficient, briefed and understood.
- Restrict and control access to areas that Vac Excavators are operating.
- Supervisors must ensure that operatives are prevented from working in Plant Red Zones at all times.
- Ensure that all the STOPThink! Fundamentals are in place prior to undertaking any works.
- If in any doubt whatsoever about what action to take stop and think and consult your Line Manager or Safety Advisor.

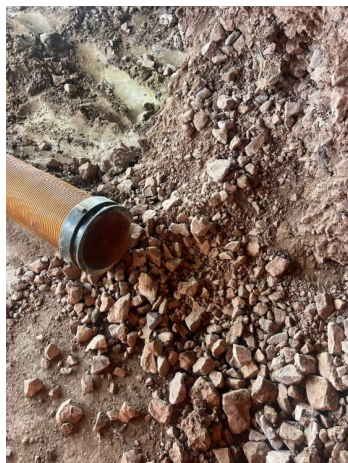
Vacuum Excavator Hose.

- The SSoW does not adequately specify the restriction on operatives proximity to the Excavator/suction hose whilst it is in operation.
- The POWRA did not detail that operatives are to maintain that safe distance away from the vac ex whilst the hose is operational.
- Neither the supervisor, vac-Ex operator or any colleagues stopped the IP from being at risk.
